Saving a doomed reservoir

Erhard Kruger*(AI) and Marelize Mostert** describe the rehabilitation of Waterval Reservoir, Roodepoort, Johannesburg in South Africa

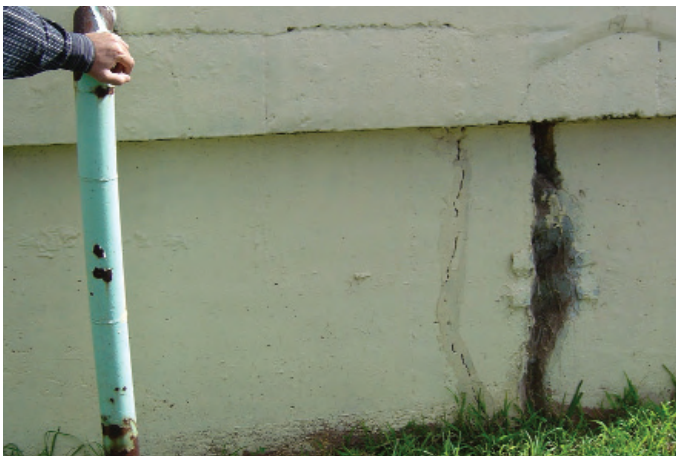
During the 1990s large cracks developed in the reservoir wall. With time, the width of these cracks increased, resulting in some of the cracks being up to 20mm wide (Fig 1). Various unsuccessful attempts were made to seal these cracks with sealants and bandages. Eventually the reservoir had to be decommissioned in 2001 due to excessive leakage and concerns regarding its structural integrity, situated adjacent to a residential area.

- 1 Cracks in the reservoir
- 2 Complex cross section of the wall

The inadequate strength of the wall was addressed by constructing a new post-tensioned concrete wall on the inside of the existing reservoir wall. Since the water-tightness of the reservoir floor was also suspect, it was decided to line the whole reservoir, including the new wall, to achieve water-tightness.

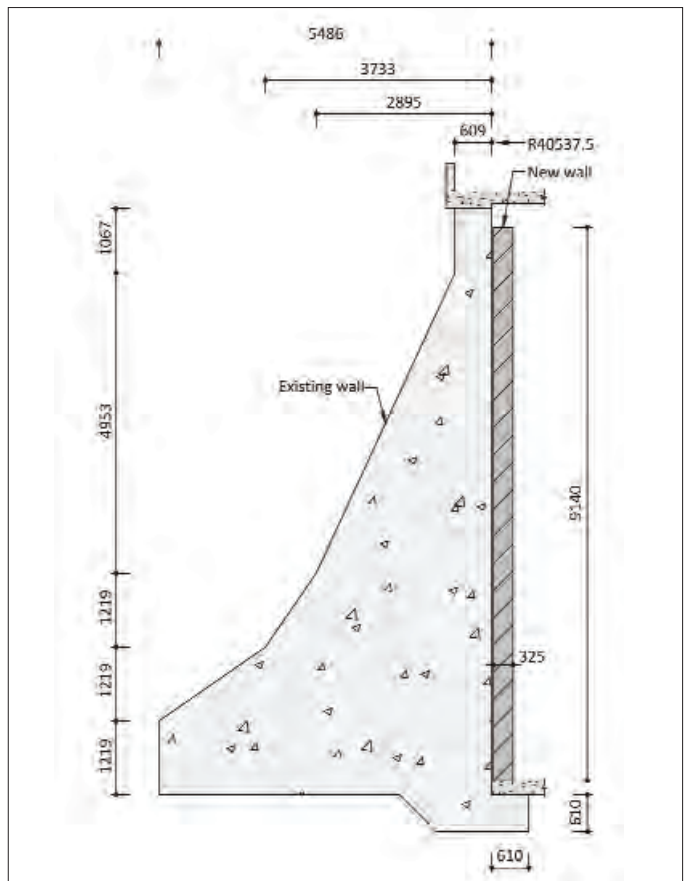
2

The wall has a fairly complicated section (see Fig 2). Over the top 1.1m, the wall thickness is 609mm. Over the next 5m, the wall thickens to 3m. Over the next 1.2m it thickens to 3.8m, and over the next, 1.2m to 5.5m. Over the bottom 1.2m the thickness remains constant. The total internal wall height is 9.45m and the internal diameter of the wall is 81.075m. On the inside of and at the bottom of the wall there is a toe of 610mm x 610mm supporting the floor slab. Only the top 1.1m portion of the wall is reinforced.

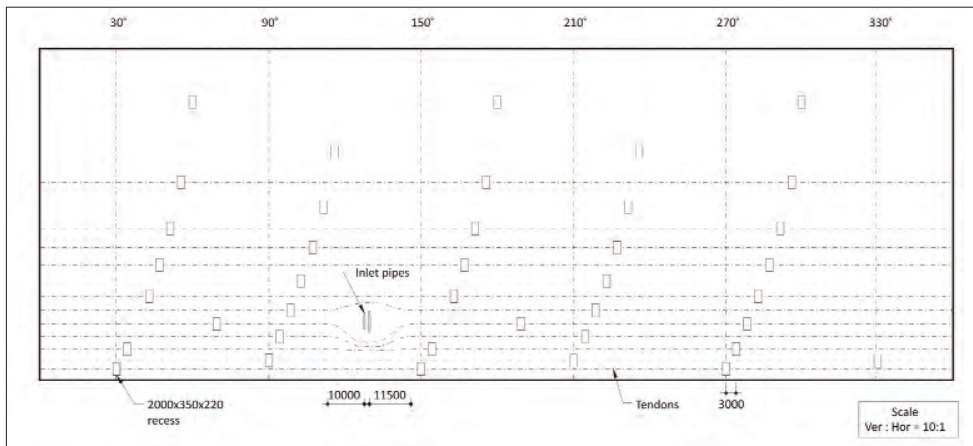
- 3 Temporary recess for the wall jacks
- 4 New inlet pipes and flexible couplings

bearing. The concrete strength is 45MPa/19mm. To avoid buttresses on the inner wall surface, the VSL type Z intermediate type post-tensioning system was used. Each tendon consists of 12, 12.9mm diameter low relaxation strands. Temporary recesses, 2000mm long x 350mm high x 220mm deep, were provided in the wall for the jacks (see Fig 3). Three stressing points, spaced at 120° on the circumference of the wall, were provided on each tendon level. The stressing points on every alternate tendon were staggered. Tendons clashing with the two inlet pipes were displaced vertically locally at the pipe positions. Recesses at each stressing point were staggered by 3m (measured centre to centre) on the circumference. After post-tensioning of tendons the recesses were filled with a high strength non-shrink grout.

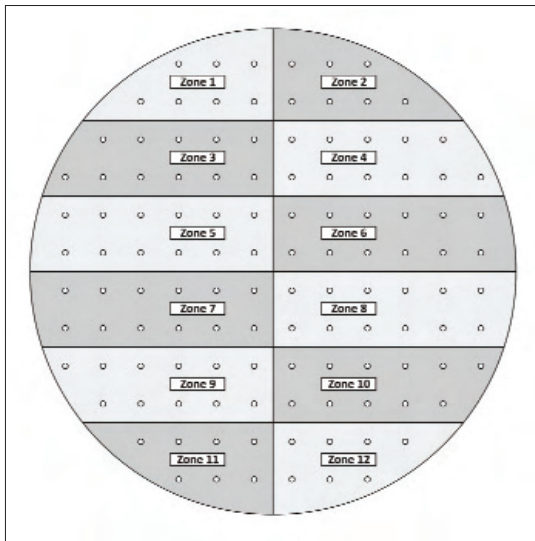
- 5 Leak detection zones
- 6 Pipe connection to drain leakage water
- 7 Detail of liner connection of wall to floor slab

Due to the large area being lined, the reservoir was divided into 12 zones to facilitate easier detection of leaks (see Fig 5), each zone containing a segment of the floor and wall, as well as a number of columns.

Zones were separated by fixing the liner to the floor slab and wall on the borders of the zone with double-sided adhesive tape. The existing scour channel on the centre line of the reservoir was changed to a drainage channel. Mass concrete separation strips coinciding with the borders of drainage zones, were cast across the width of the drainage channel, as well as along the centre of the channel, thus dividing the channel into 12 sections. At the lower end of each section of the channel, a perforated 32mm diameter HDPE pipe was installed upslope from and against the separation strip running across the channel, to collect any leakage

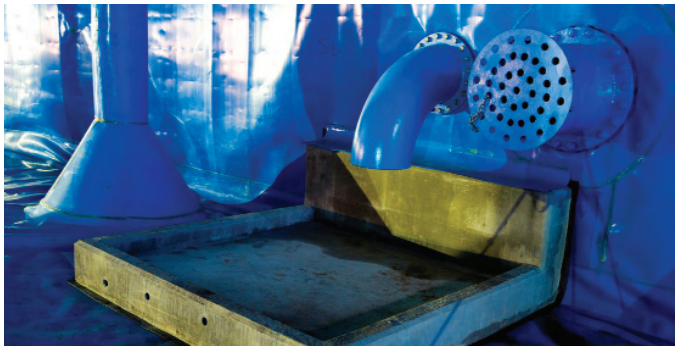
- 8 RC concrete distilling basin
- 9 Wall formwork fixed to the tie rods
- 10, 11 Post tensioning of the wall
- 12 View of the lined reservoir

at the inlet pipes to prevent horizontal displacement of the liner during filling of the reservoir, which would exert undesirable forces on the wall to floor liner connection (see Fig 8). In addition, baffle plates were added to the inlet pipes to dissipate energy during filling, thus protecting the liner.
